Inspection Report

Access Home Inspection Services Inc. Lic # 332363

Date: 14/12/2011	Time: 01:00 PM	Report ID: 1214102
Property:	Customer:	Real Estate Professional:

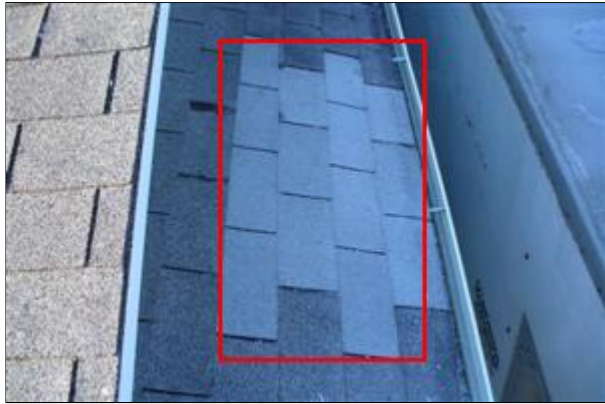
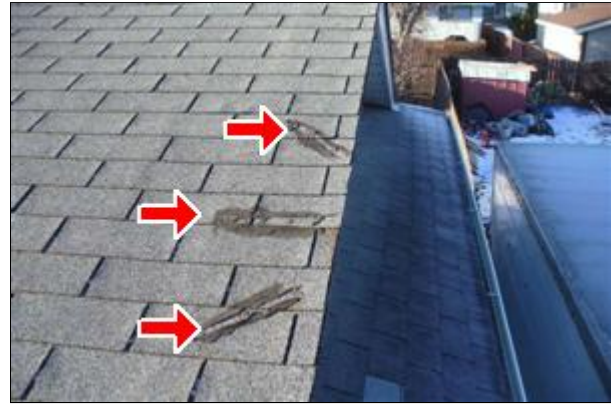
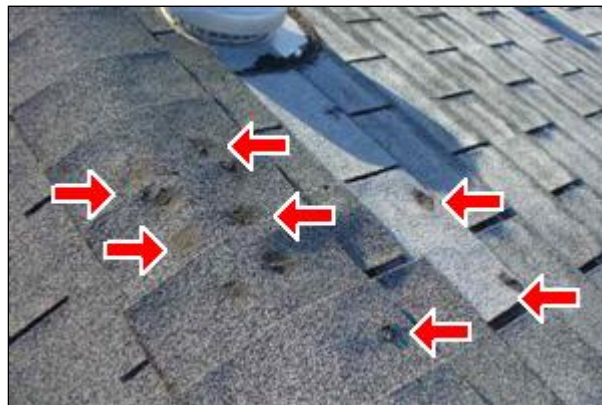
1.0 The Roof shingles is nearing the end of its life cycle and is deteriorated at the "entire roof". Roof covering will need replacing before 5 years. A qualified person should repair or replace as needed.

Patched area on right side of house on the lower roof, appears to have been a chimney removed and repaired (patch on siding, roof and tar on upper roof)

Several spots of tar indicating some patching

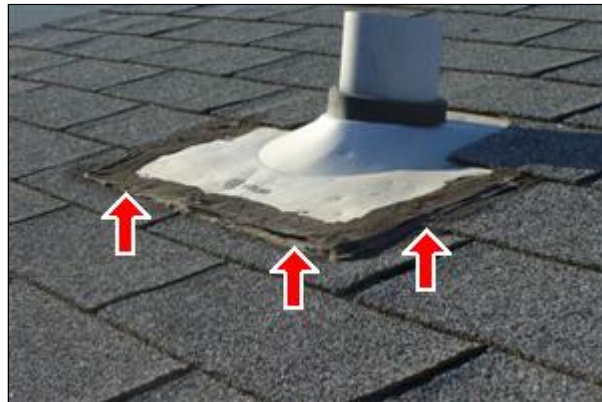
1.1 Picture 1

1.1 Quite a bit of roofing tar around flashing, shows some ongoing maintenance on roof, perhaps also leaks, No evidence of leaks inside the attic.

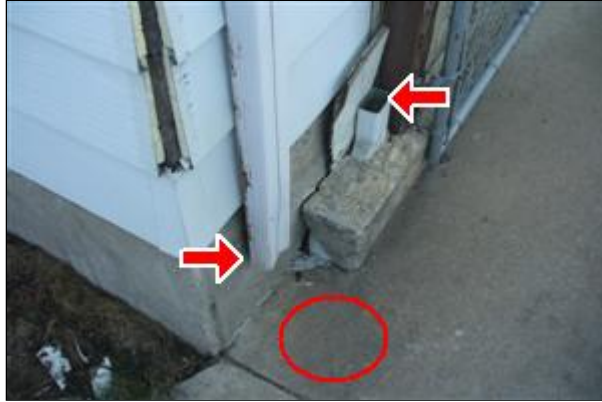
1.3 Picture 1

1.3 (1) Rear downspout is re directed from draining underground and just dumps water on the drive way. This could be a slip and fall hazard in the winter time.

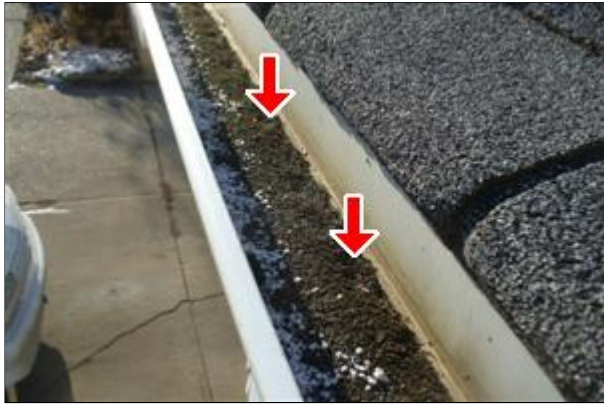
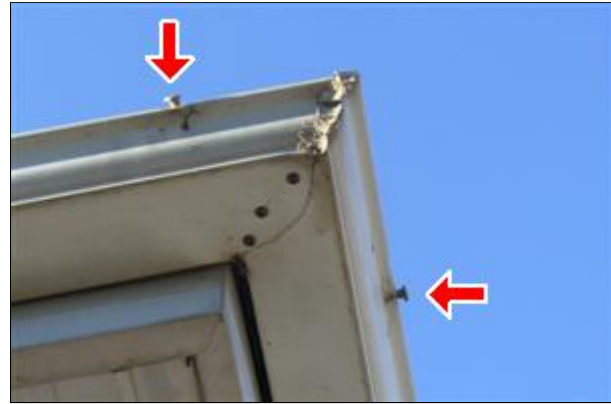
(2) Gutters are dirty and require cleaning. this is a maintenance issue. Also several nail pops.

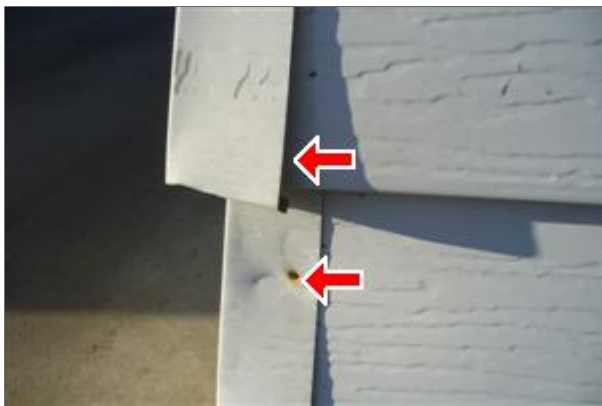
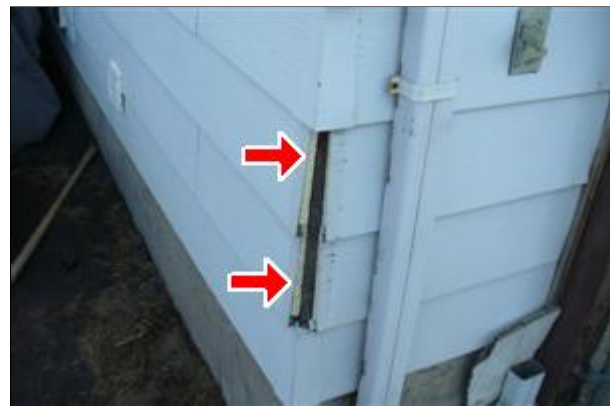
2.0 (1) The Aluminum siding at the left corner and left corner (facing rear) damaged. missing or loose. Deterioration can eventually occur if not corrected. A qualified person should repair or replace as needed.

- (1) The Aluminum siding at the left corner and left corner (facing rear) damaged. missing or loose. Deterioration can eventually occur if not corrected. A qualified person should repair or replace as needed.
- (3) Caulk around the power entry on the right side of the house.
- (4) Front dryer vent is not attached to the wall, attach and caulk. This can be done by a qualified person.
- (5) Patch on siding at back of house.
- (6) Siding is missing along back of the house where a deck has been removed. I recommend that a qualified person fix this.

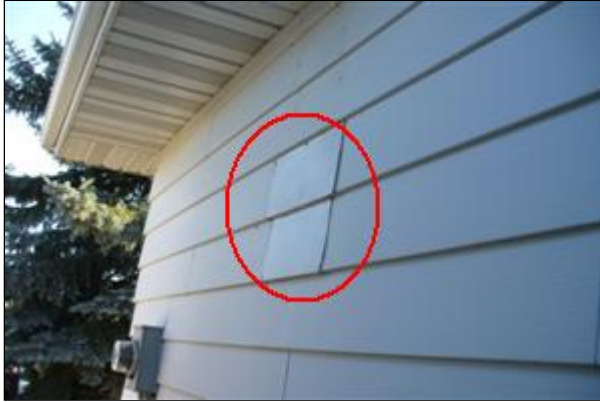
2.0 Picture 3

(2) A section of siding has been patched on the right side of the house. Perhaps was a chimney at one time.

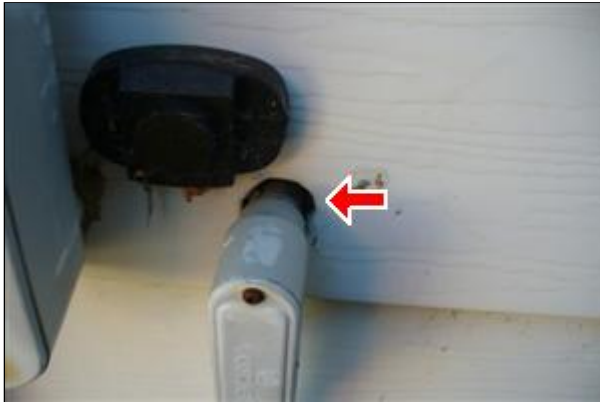
2.0 Picture 4

(4) Front dryer vent is not attached to the wall, attach and caulk. This can be done by a qualified person.

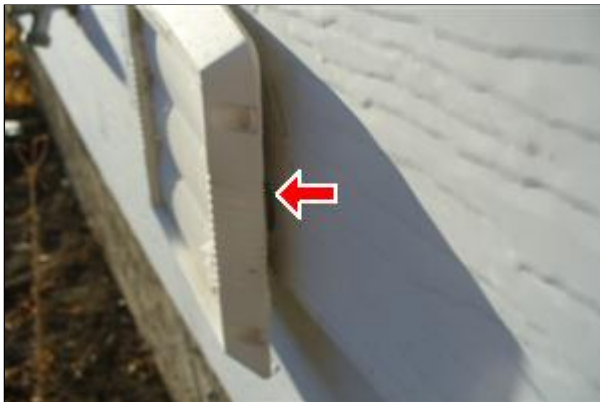
2.0 Picture 5

(5) Patch on siding at back of house.

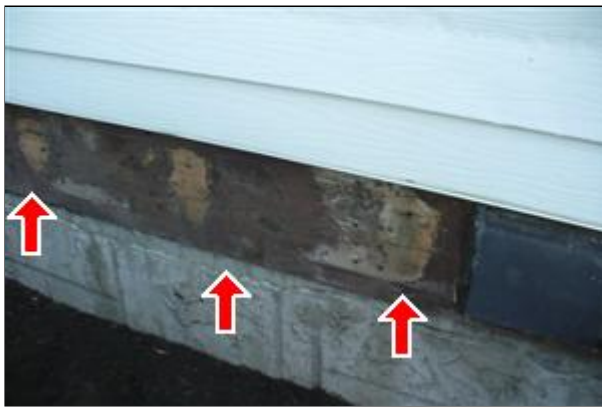
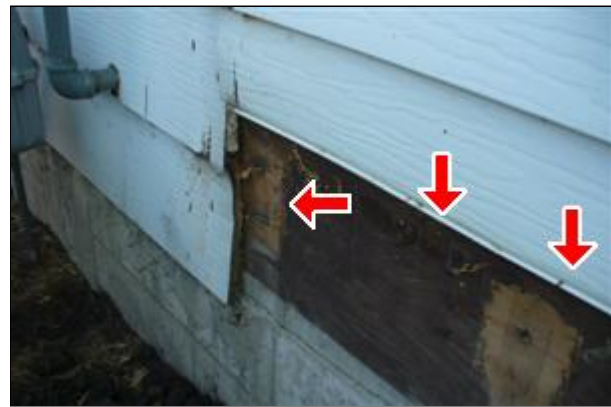
(6) Siding is missing along back of the house where a deck has been removed. I recommend that a qualified person fix this.

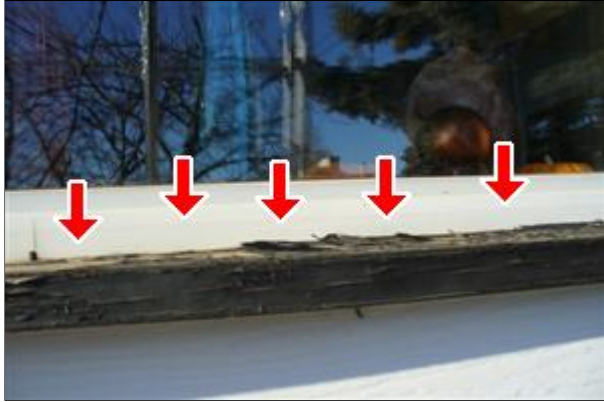
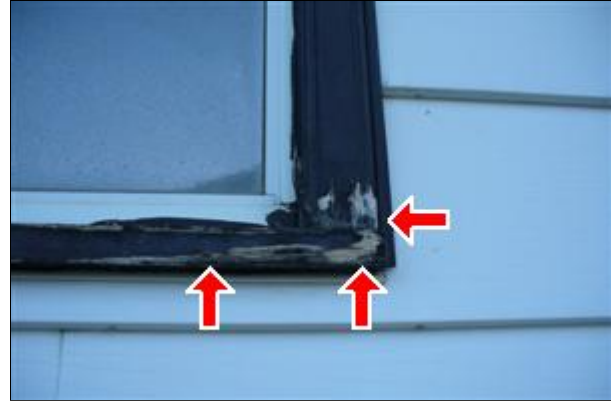
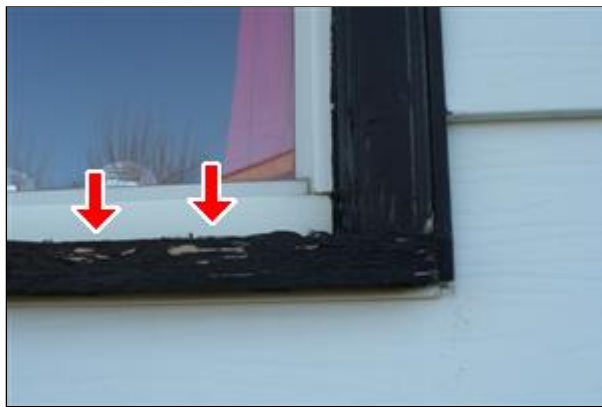
2.2 (1) The wood trim is peeling paint at most windows. Further deterioration may occur if not repaired. I recommend a qualified contractor inspect and repair as needed.

- (1) The wood trim is peeling paint at most windows. Further deterioration may occur if not repaired. I recommend a qualified contractor inspect and repair as needed.
- (2) Broken basement window at the front right corner of the house. this needs to be replaced. A qualified person should do this.

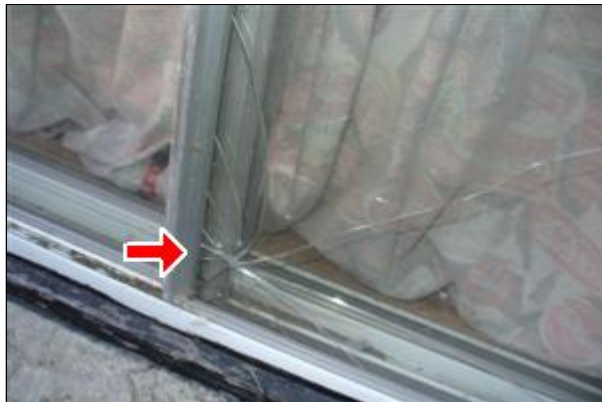
2.2 Picture 4

(2) Broken basement window at the front right corner of the house. this needs to be replaced. A qualified person should do this.

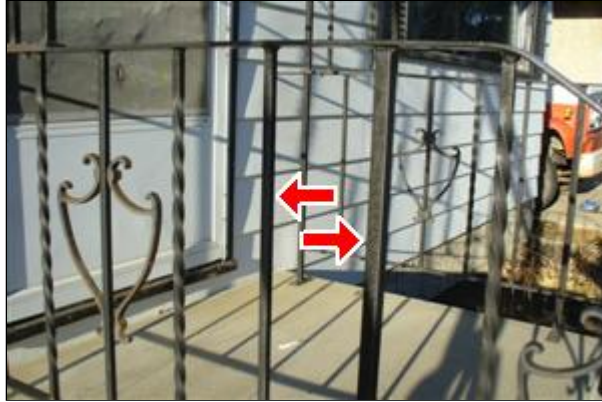
2.3 Picture 1

2.3 (1) The guard rail at steps on porch at the front of home are spaced to far apart for safety. Spacing more than 4 inches apart could allow an adult, child or pet to fall through. The maximum space between pickets should be four inches.

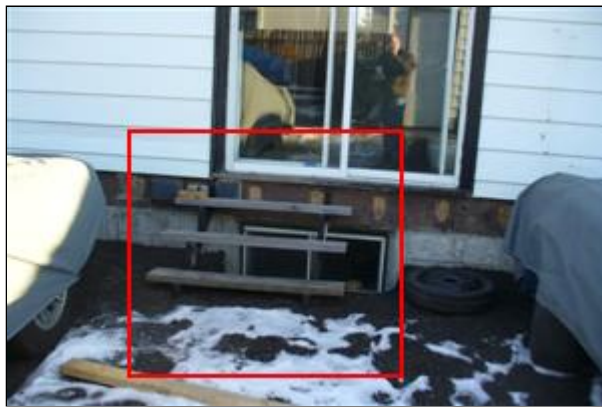
2.3 Picture 2

(2) Missing hand rail on back steps at the sliding door. Also steps are too steep. I recommend that a qualified contractor replace back steps.

(2) Missing hand rail on back steps at the sliding door. Also steps are too steep. I recommend that a qualified contractor replace back steps.

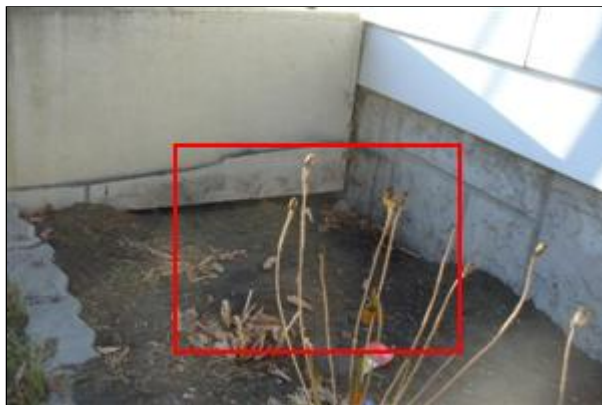
2.4 Picture 1

(2) Grade to the right of the front door needs to be improved so that water is directed away from the foundation.

(2) Grade to the right of the front door needs to be improved so that water is directed away from the foundation.

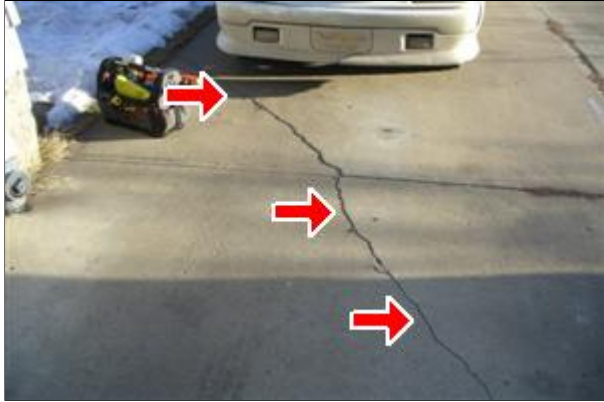
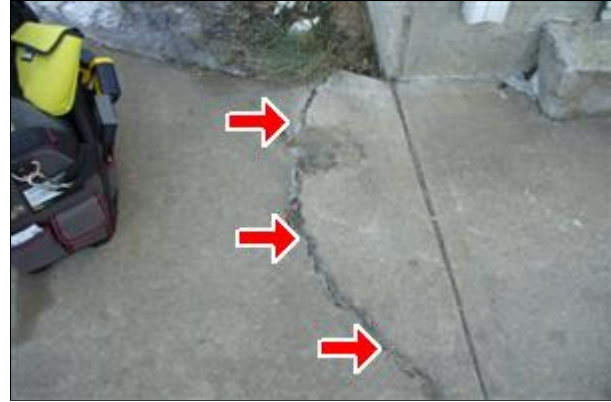
(3) Driveway has several large cracks by the house.

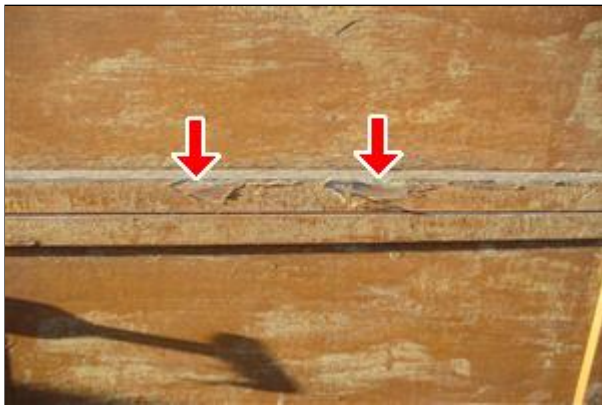
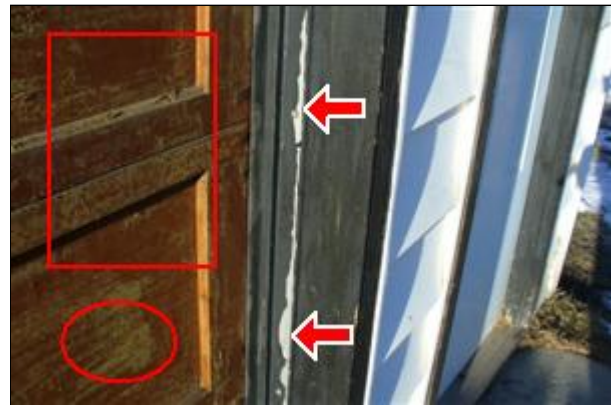
3.3 (1) The garage door at the garage is weathered. This is a maintenance issue and is for your information. A qualified person should repair or replace as needed.

(1) The garage door at the garage is weathered. This is a maintenance issue and is for your information. A qualified person should repair or replace as needed.

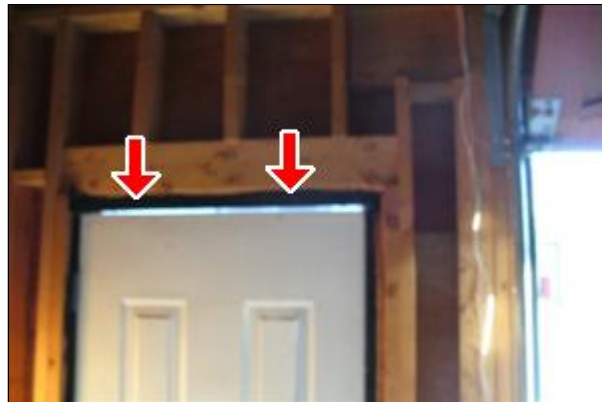
3.3 Picture 3

(2) Space above garage man door.

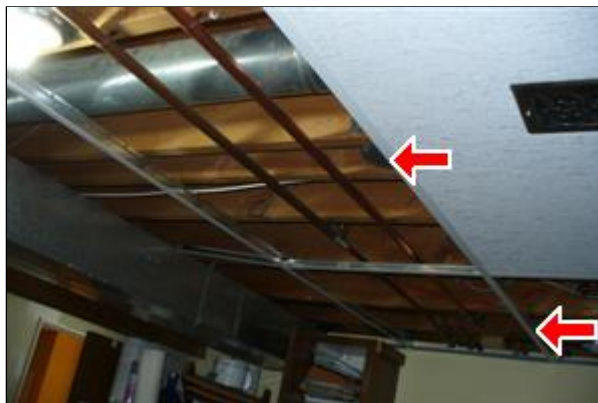
4.0 Picture 1

4.0 (1) Missing several ceiling tiles in the basement.

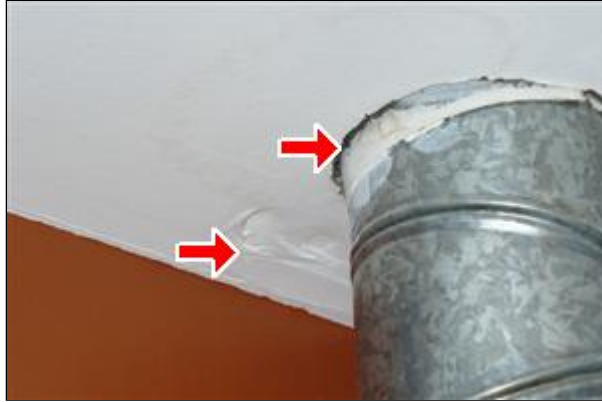
4.0 Picture 2

(2) Damage behind exhaust fan in the kitchen.

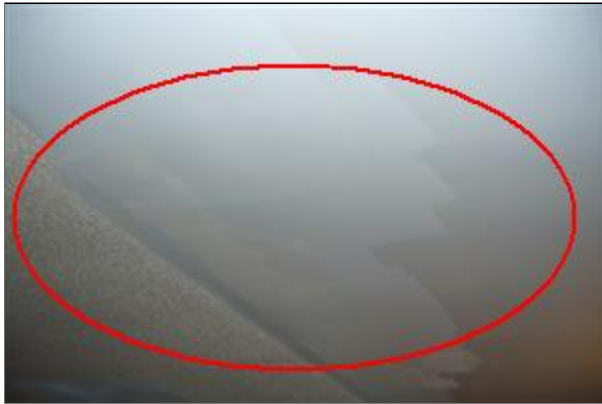
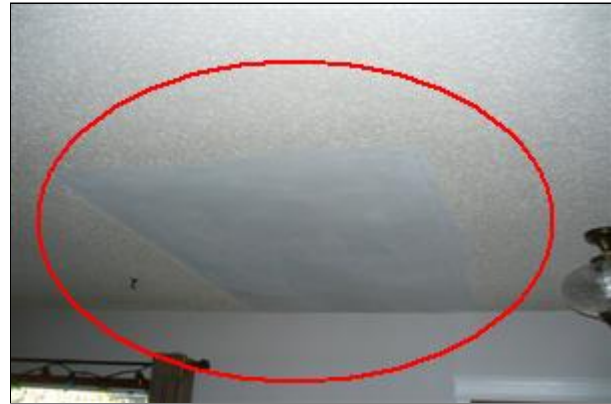
(3) Several spots in the main living area where it appears that a closet? and wall have been removed. Recommend a qualified contractor to address.

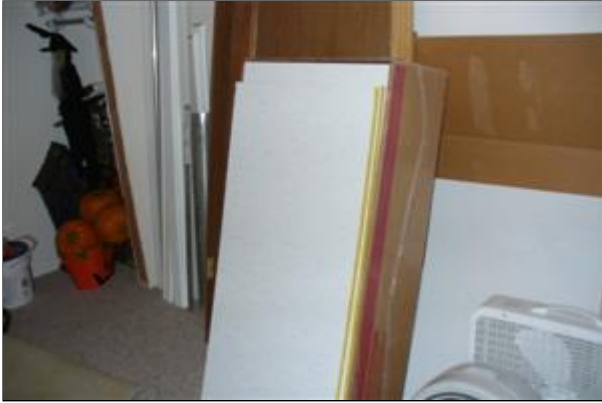
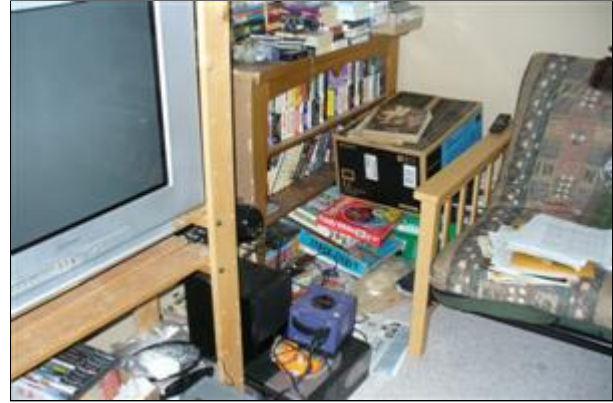
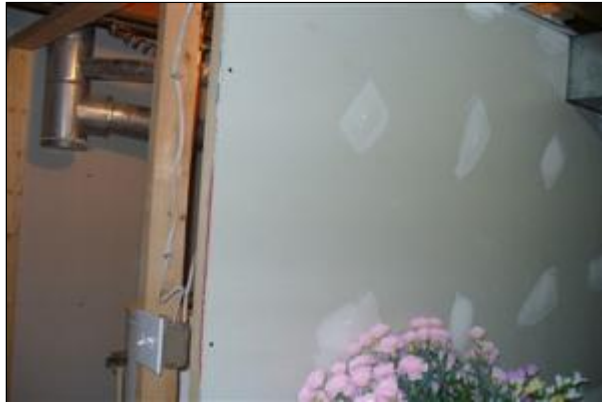
4.1 (1) Several unfinished walls in the basement. Lots of storage throughout the house.

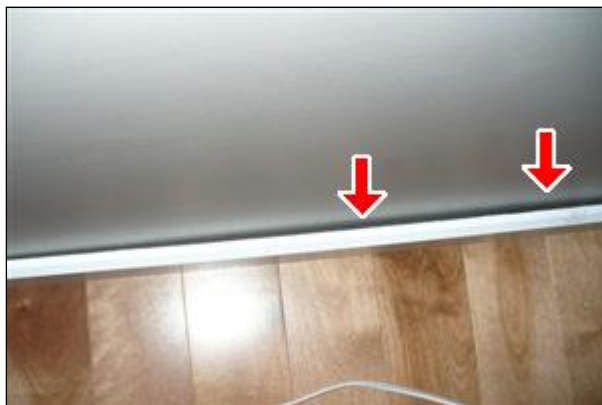
4.1 Picture 4

(2) Trim in living room is coming loose from the wall, Also the trim around the pocket doors to the back sliding door is missing.

(2) Trim in living room is coming loose from the wall, Also the trim around the pocket doors to the back sliding door is missing.

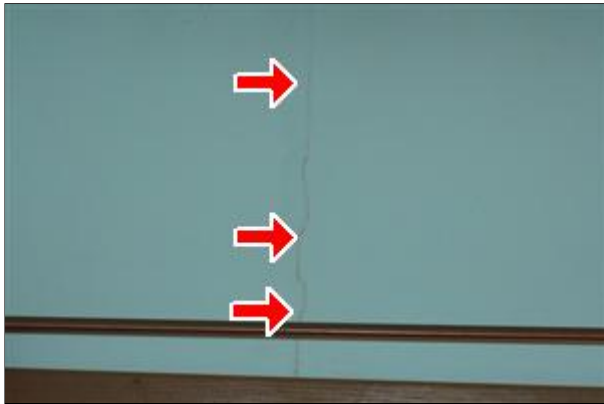
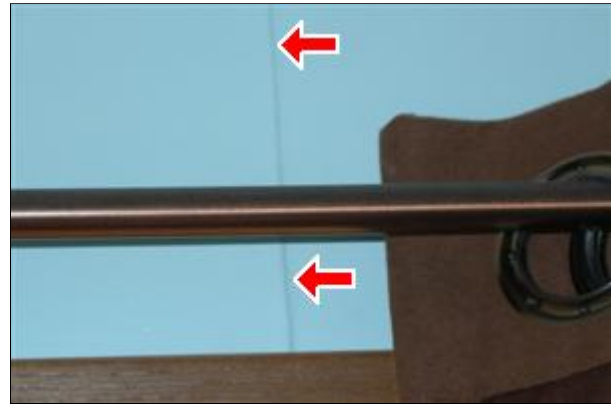
(3) 2 cracks in the wall above the window in the master bedroom. These are minor and require patching. A qualified person can correct this.

(3) 2 cracks in the wall above the window in the master bedroom. These are minor and require patching. A qualified person can correct this.

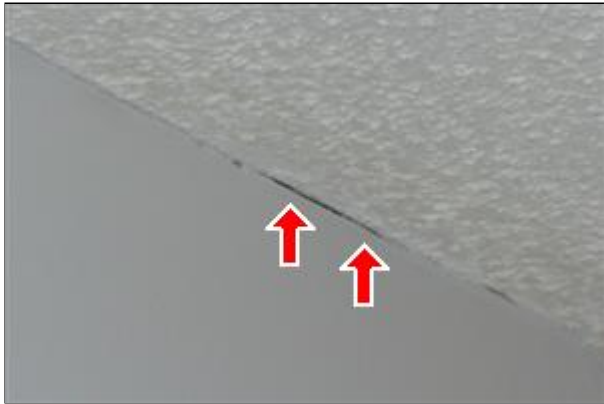
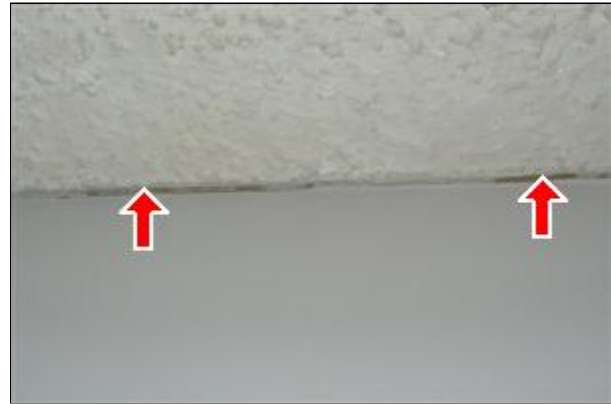
(4) Some spaces at the top of the wall at the 2nd bedroom.

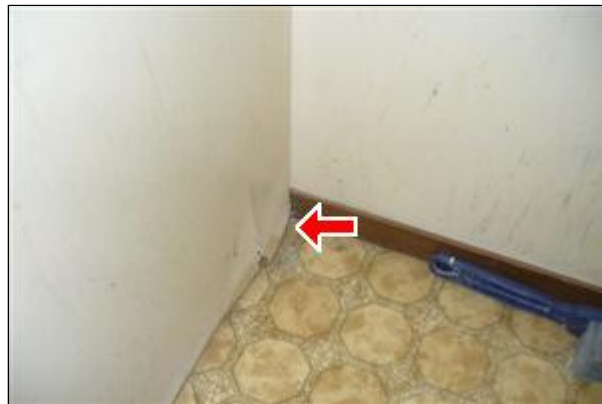
4.1 Picture 9

(5) damage in the pantry lower wall by the stove

(5) damage in the pantry lower wall by the stove

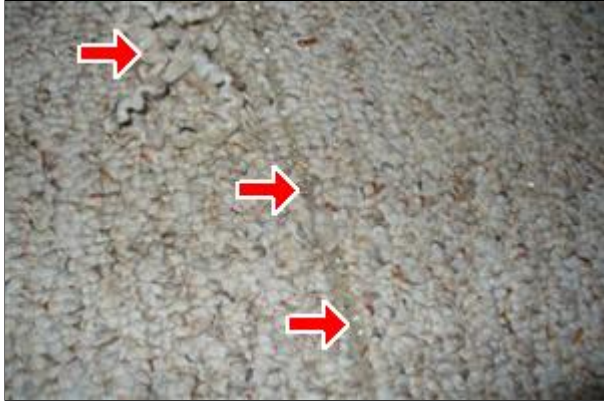
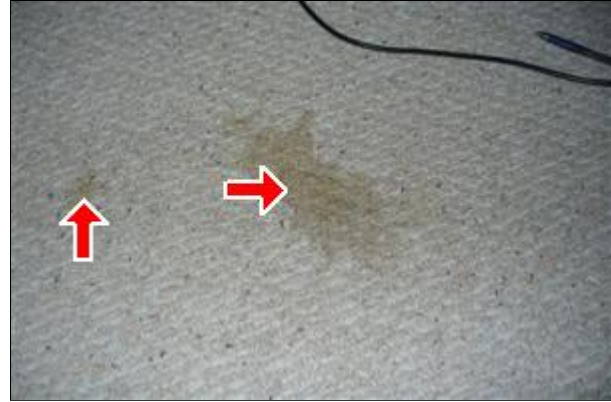
4.2 (1) Carpet in the basement bedroom is damaged (unraveling) also loose edges in several places in the basement. Several stains in carpet in the basement also.

(1) Carpet in the basement bedroom is damaged (unraveling) also loose edges in several places in the basement. Several stains in carpet in the basement also.

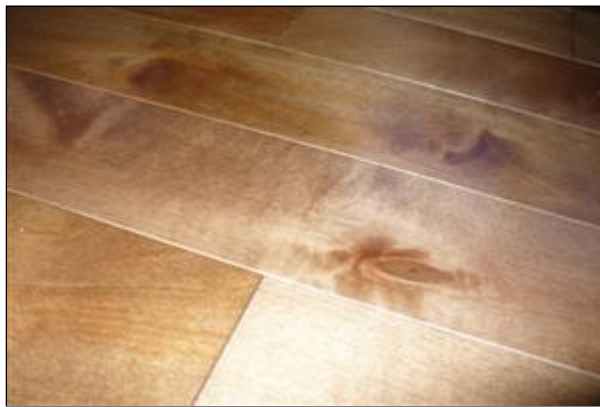
4.2 Picture 3

(2) Hardwood floor in kitchen shows damage from fridge? rolling around on floor. Note this shows up in reflected sunlight, not in pictures

(2) Hardwood floor in kitchen shows damage from fridge? rolling around on floor. Note this shows up in reflected sunlight, not in pictures

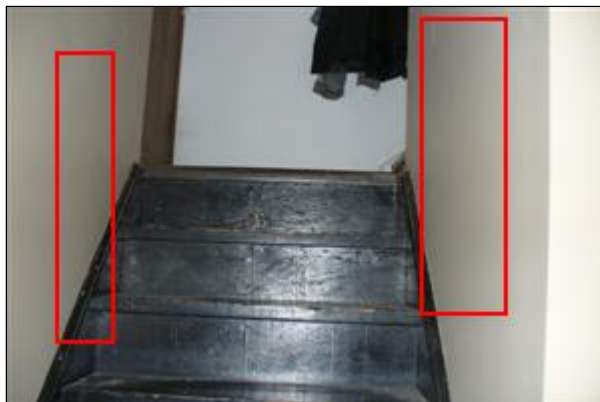
4.3 Picture 1

4.3 The hand/guard rail for the stairs to lower level is missing. A fall or injury could occur if not corrected. A handrail should be installed for safety.

The hand/guard rail for the stairs to lower level is missing. A fall or injury could occur if not corrected. A handrail should be installed for safety.

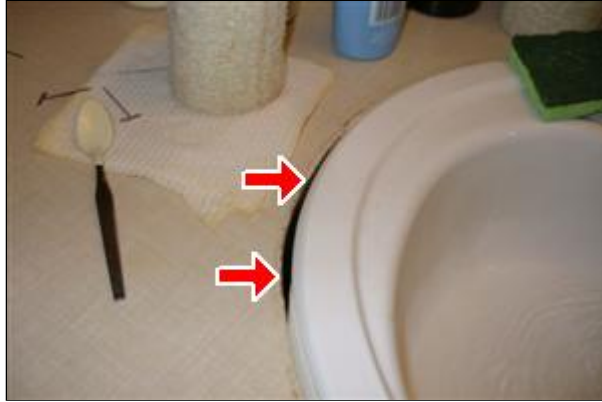
4.4 Picture 1

4.4 (1) Countertop is loose, not fastened securely in the basement bathroom. This is a cosmetic issue for your information. Recommend repair or replace as necessary.

(1) Countertop is loose, not fastened securely in the basement bathroom. This is a cosmetic issue for your information. Recommend repair or replace as necessary.

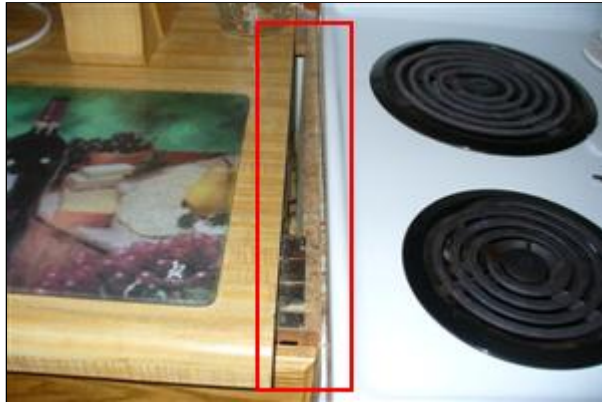
4.4 Picture 2

(2) Main counter top in kitchen is too short beside the stove (1 inch gap) I recommend that it be replaced.

(2) Main counter top in kitchen is too short beside the stove (1 inch gap) I recommend that it be replaced.

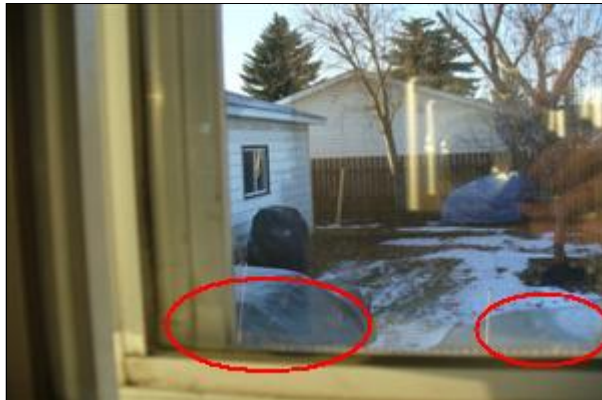
4.6 Picture 1

4.6 (1) Screen in master bedroom window is damaged. I recommend that it be repaired or replaced.

- (1) Screen in master bedroom window is damaged. I recommend that it be repaired or replaced.
- (2) Some condensation damage under the windows in the master bedroom. Currently less than 6% moisture.

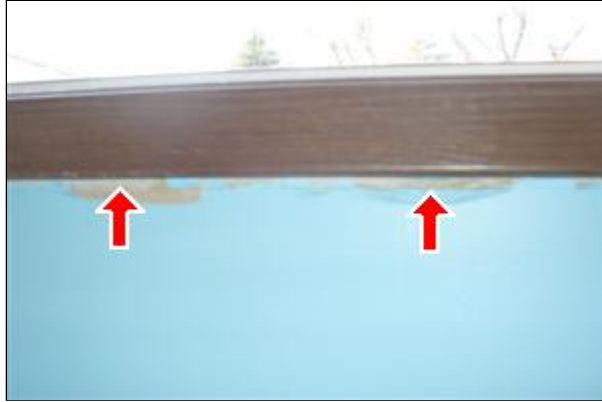
4.6 Picture 2

(2) Some condensation damage under the windows in the master bedroom. Currently less than 6% moisture.

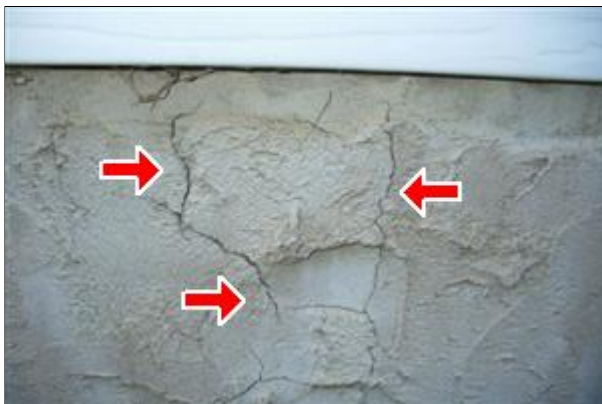
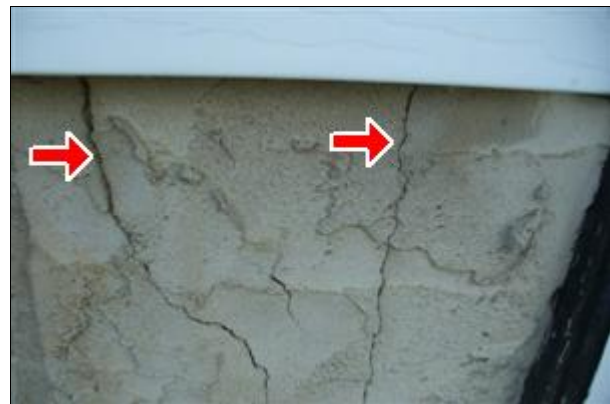
5.0 (1) The main beam in the house has caused some cracking at both sides of the house in the middle. This is a water intrusion issue. Currently cracks do not extend below grade.

- (1) The main beam in the house has caused some cracking at both sides of the house in the middle. This is a water intrusion issue. Currently cracks do not extend below grade.
- (2) Visible signs of water intrusion in the basement (along rear of home) at window are present from wall removed for?. Water intrusion can lead to more costly repairs and increase damage if not corrected.. I recommend further investigation or correction by a qualified licensed contractor or water infiltration specialist.

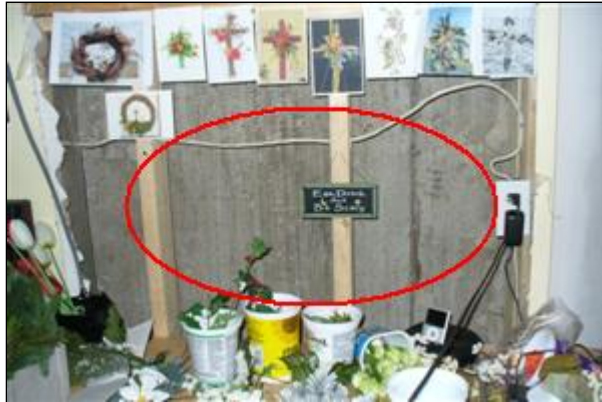
5.0 Picture 3

(2) Visible signs of water intrusion in the basement (along rear of home) at window are present from wall removed for?. Water intrusion can lead to more costly repairs and increase damage if not corrected.. I recommend further investigation or correction by a qualified licensed contractor or water infiltration specialist.

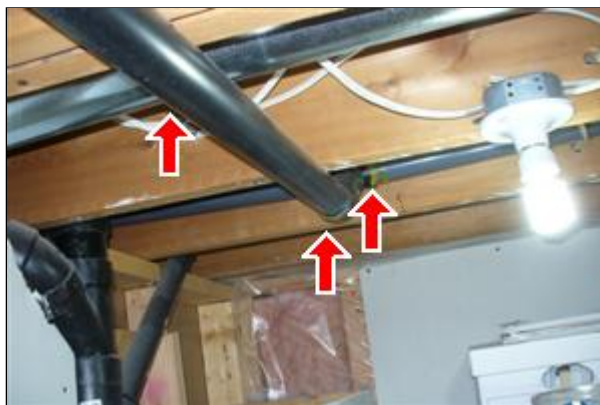
6.0 Picture 1

6.0 (1) there is a vent pipe that is tied in low. This will eventually block and prevent gasses from escaping. A qualified plumber should correct.

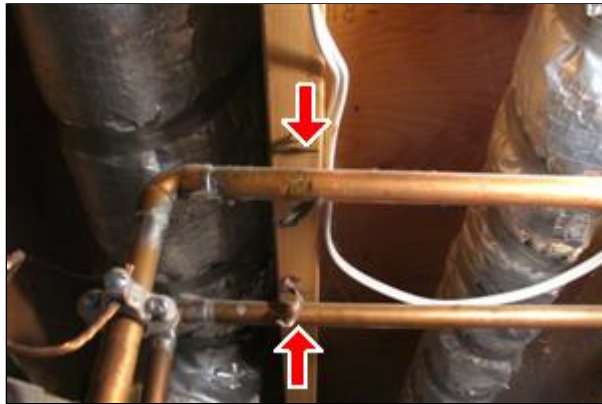
6.0 Picture 2

(2) Pipes have been disconnected from the ceiling in the basement above the hot water heater. This is for information purposes only.

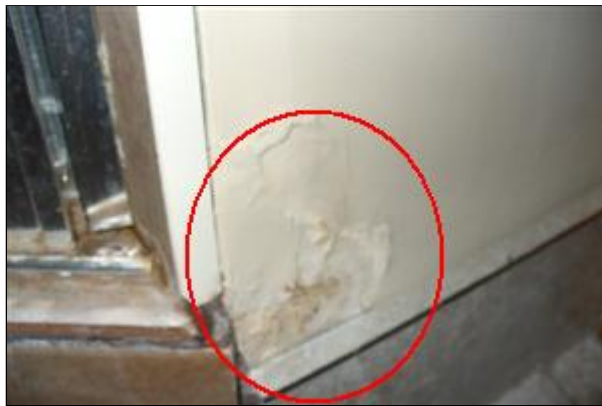
6.1 Picture 1

6.1 (1) Basement shower appears not to shut all the way off (drips) Also some wall damage to the side of the door.

- (1) Basement shower appears not to shut all the way off (drips) Also some wall damage to the side of the door.
- (2) Upstairs shower shows a lot of grout deterioration. I recommend a contractor to remove and probably replace whole wall, due to water infiltration.
- (3) Back outside tap is broken and will need to be replaced. I recommend that a qualified person do this.

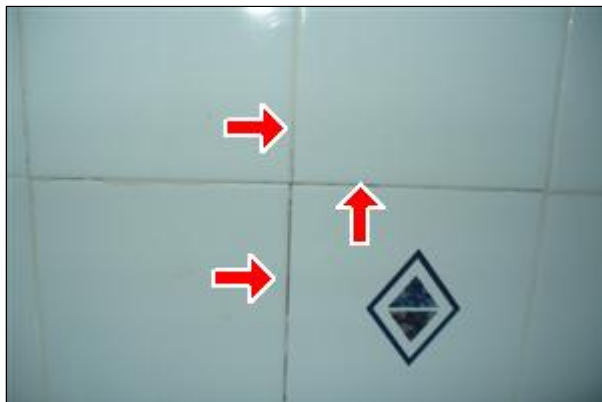
6.1 Picture 2

(2) Upstairs shower shows a lot of grout deterioration. I recommend a contractor to remove and probably replace whole wall, due to water infiltration.

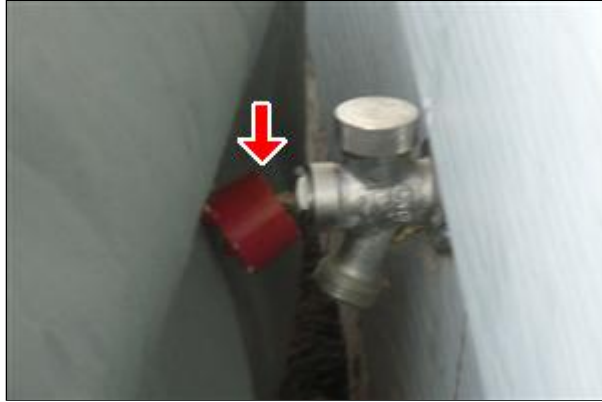
6.1 Picture 3

(3) Back outside tap is broken and will need to be replaced. I recommend that a qualified person do this.

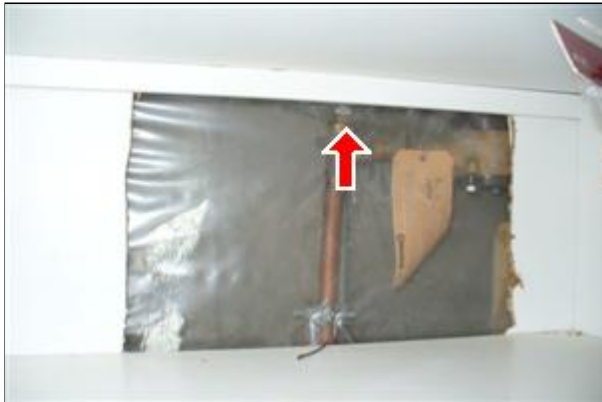
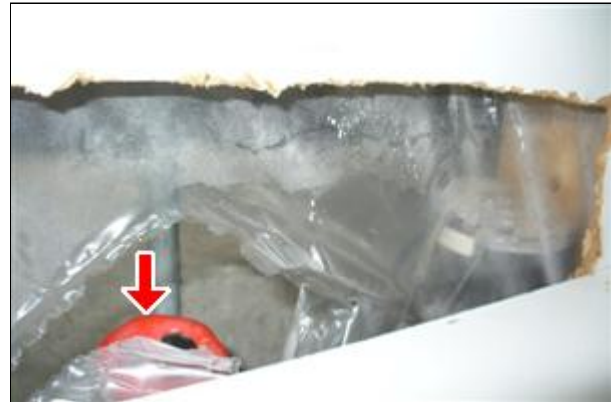
6.3 Main water shut off in located in basement kitchen cabinet.

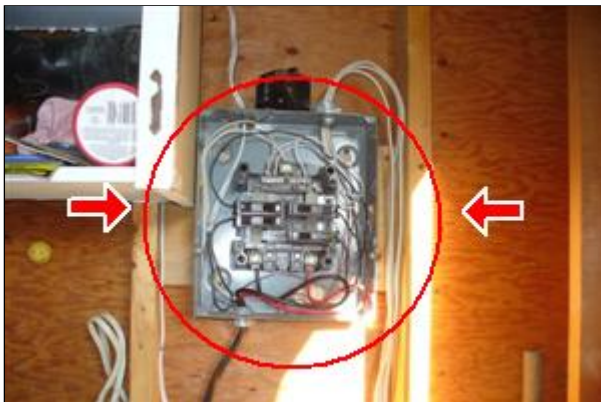
7.1 Picture 1

7.1 (1) The main panel box is located at the garage. The panel is missing screws and is missing cover (DANGEROUS). This is a safety issue that needs to be corrected. A qualified licensed electrical contractor should perform repairs that involve wiring.

- (1) The main panel box is located at the garage. The panel is missing screws and is missing cover (DANGEROUS). This is a safety issue that needs to be corrected. A qualified licensed electrical contractor should perform repairs that involve wiring.
- (2) Main Panel has a lot of junk around it.

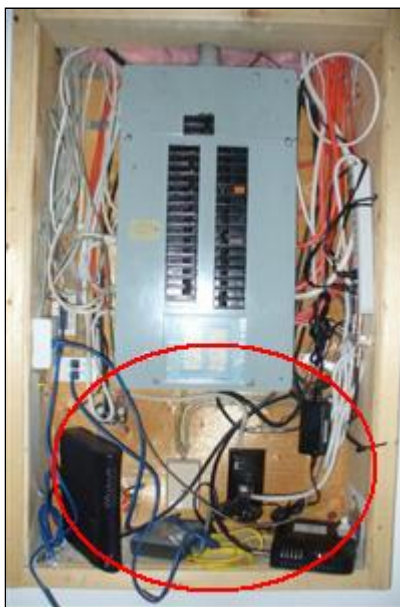
7.1 Picture 2

(2) Main Panel has a lot of junk around it.

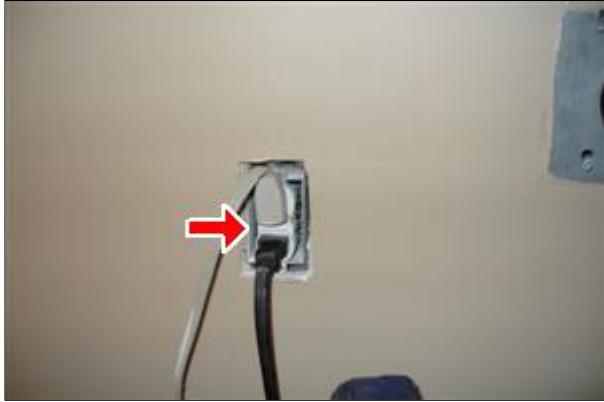
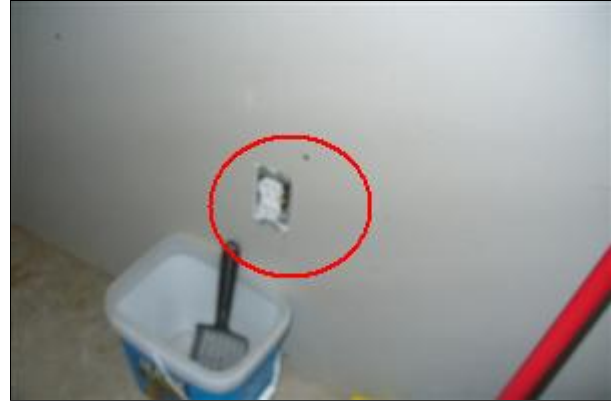
7.3 (1) At least one is missing cover-plate in the utility room and in storage room (at lower level). Exposed wiring is considered unsafe until repaired. A qualified licensed electrical contractor should perform repairs that involve wiring.

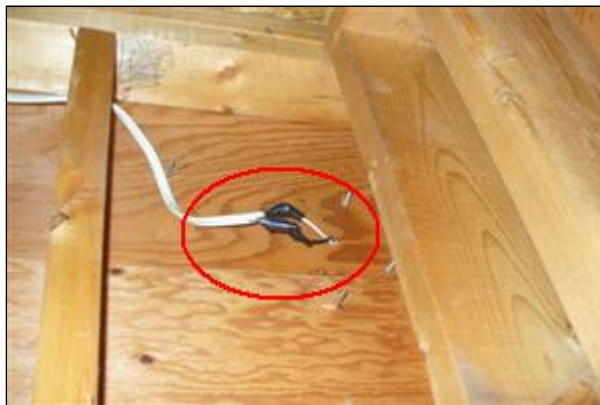
7.3 Picture 3

(2) One splice needs placing inside a box with a cover-plate in the garage. A qualified licensed electrical contractor should perform repairs that involve wiring.

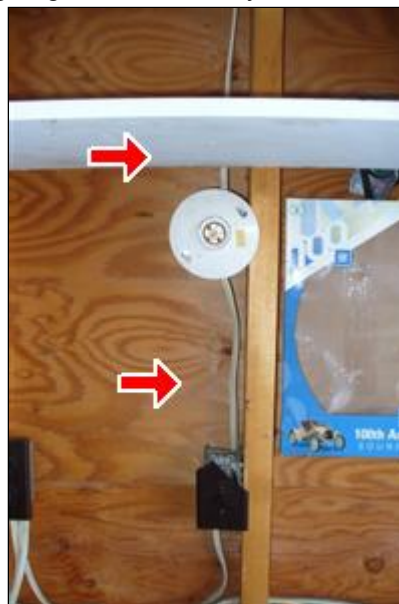
7.3 Picture 4

(3) Broken cover plate and missing bulb in garage, this is a safety hazard. I recommend that a qualified person correct this.

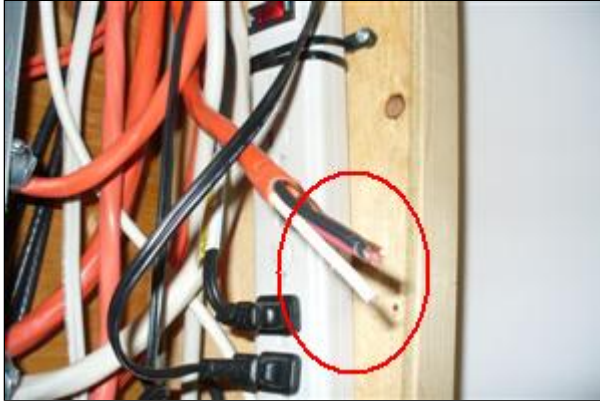
7.3 Picture 5

(4) abandoned wire beside electrical panel.

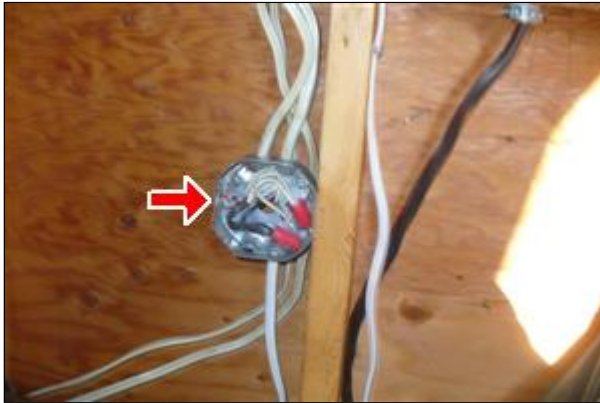
7.4 Picture 1

(2) there is a junction box in the garage that needs a cover.

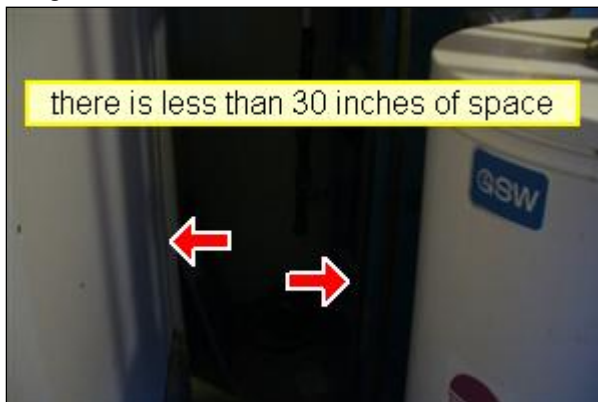
8.0 Picture 1

8.0 (1) The furnace is very old but did work at time of inspection. I am unable to determine life remaining. Also the fan is making a lot of noise.

(2) only 23" of space will make replacing furnace difficult.

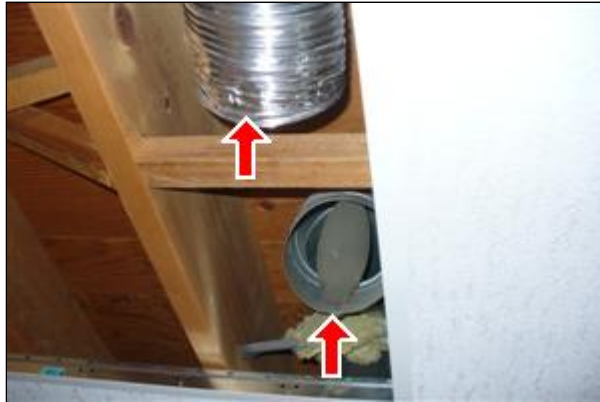
8.3 Picture 1

(2) Basement bedroom has a disconnected heat run, originally terminated at the floor board, now thru a removed ceiling tile.

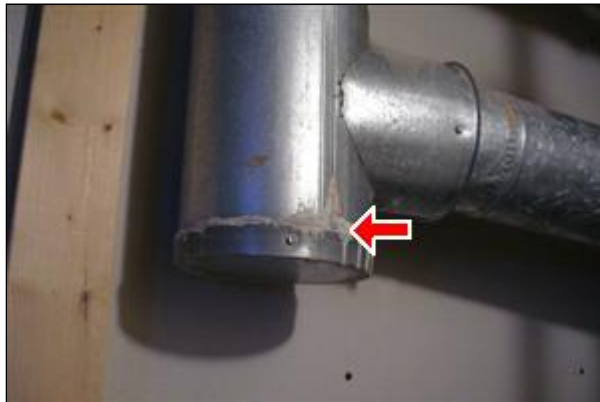
8.5 Picture 1

8.5 Some calcification around the chimney in the basement.

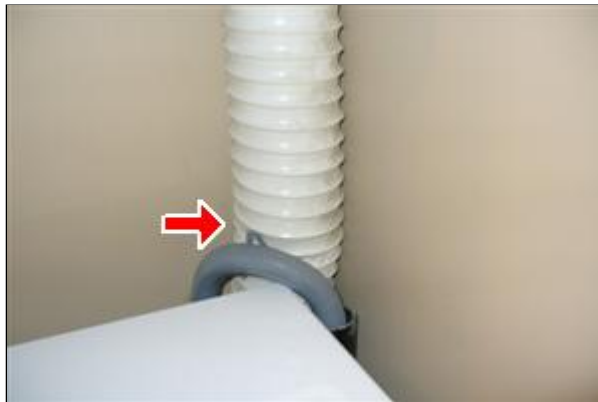
9.3 Picture 1

9.3 The dryer vent piping is damaged. Some professionals consider plastic dryer vents as generally unsafe and recommend rigid or metal flexible pipe. I recommend repair as needed.

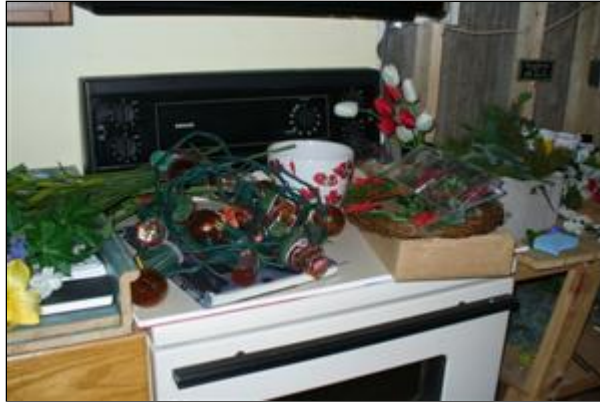
10.1 Picture 1

10.1 Basement stove not tested
